# Manhole Inspection Summary

Manhole # S29II1035MH

**Location** Address: **4231 MEADOW LN**

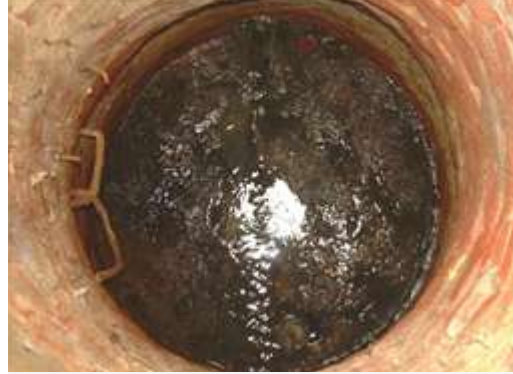
Top View

Condition: ☐ Sound ☐ Cracked ☐ Root Intrusion ☐ Deteriorated ☐ Leaks ☒ **Debris**

**Steps** Count: **5** Missing: **3** ☒ **Corroded**

Corroded and missing steps. Channel debris.

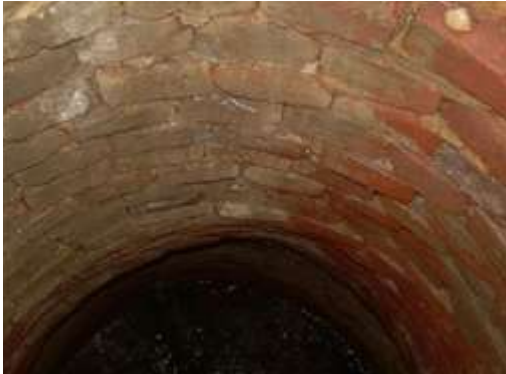
Defect

Condition: ☐ Sound ☐ Cracked ☐ Root Intrusion ☐ Loose Brick ☒ **Deteriorated**

Infiltration: ☐ None ☒ **Joint** ☐ Cracks ☒ **Mortar** ☐ Roots ☐ Wall

Infiltration: ☐ None ☐ Joint ☐ Cracks ☒ **Mortar** ☐ Roots ☐ Wall

Adjustment and Corbel deterioration and infiltration.

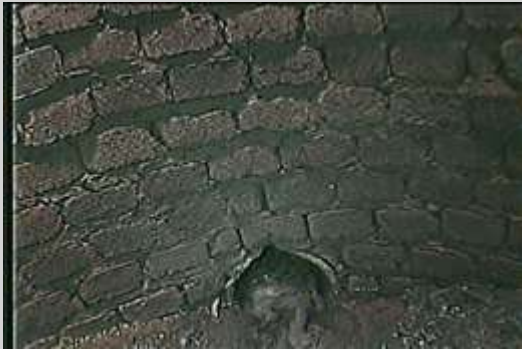
### 8 in. Circular Gravity Sewer Pipe Out @ 12 O'Clock

Barrel deterioration and infiltration.

Deposits: ☐ None ☒ **Mud** ☐ **Grassy** ☒ **Debris** ☐ Grease

Silt Depth: **2** (in.) Deposits Extent: **Medium**

Infiltration: **None** Pipe Seal Cond: **Broken**

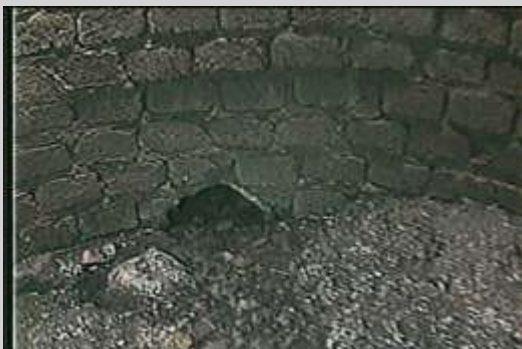
### 8 in. Circular Gravity Sewer Pipe In @ 6 O'Clock

Deposits: ☐ None ☐ Mud ☒ **Grassy** ☒ **Debris** ☐ Grease

Silt Depth: **4** (in.) Deposits Extent: **Heavy**

Infiltration: **None** Pipe Seal Cond: **Broken**
